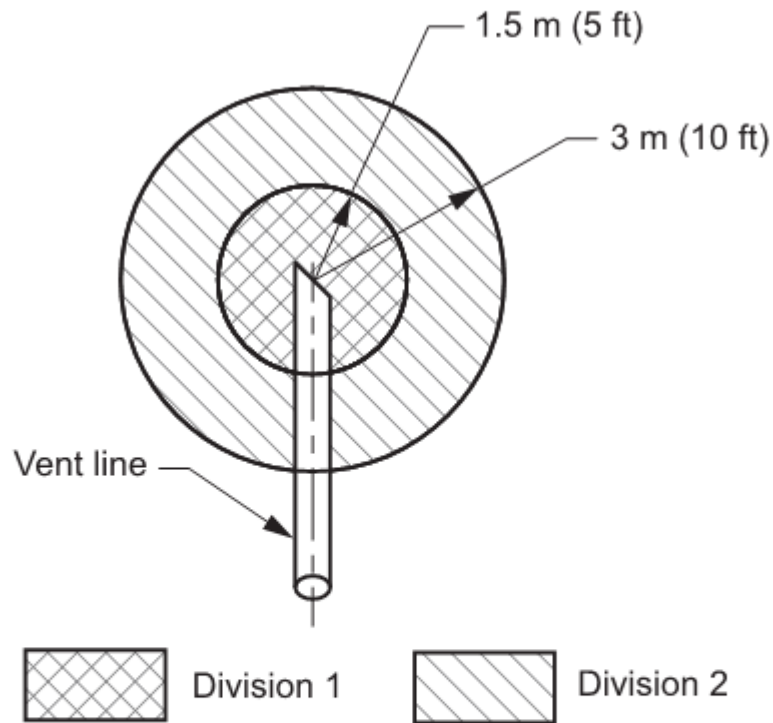
**Figure 14—Process Equipment Vent in a Nonenclosed Adequately Ventilated Area (See 8.2.3.1)**

NOTE The interior of the vent piping is Division 1. Cross hatching has been omitted for drawing clarity.
